Composite Failure Analysis Handbook Update #1

Boeing Defense & Space Group

April 1995

Final Report for the Period Aug 90 - Apr 95

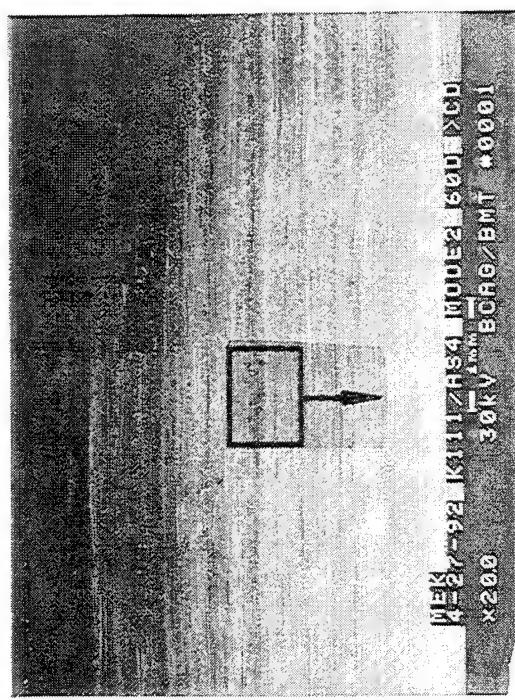
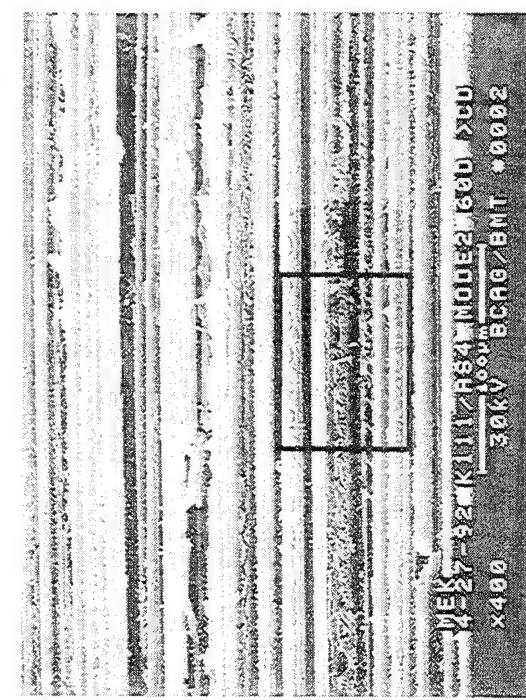
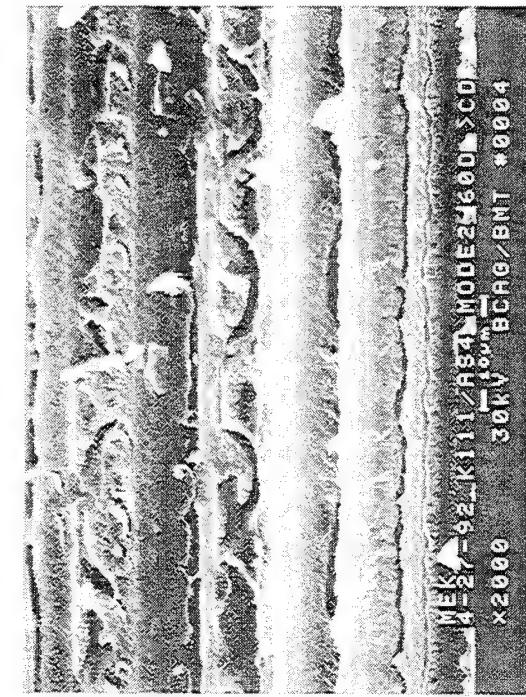
Figure 3.2.22. SEM Fractographs of a KI/II/AS4 Interlaminar Mode II Shear Fracture Surface Exposed to MEK for 24 Hours

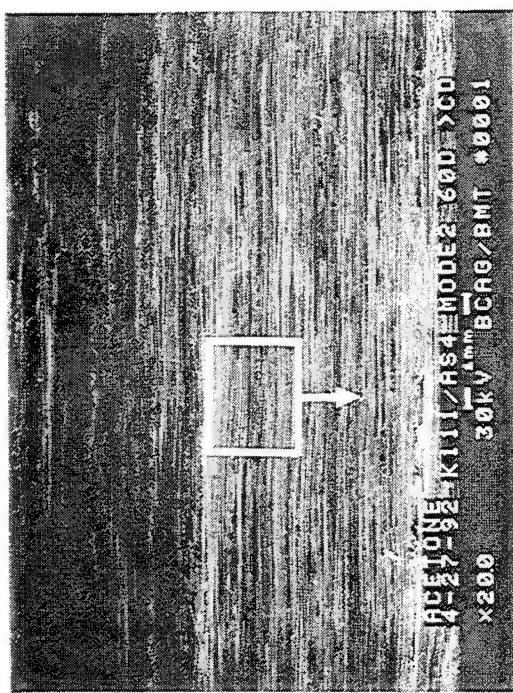
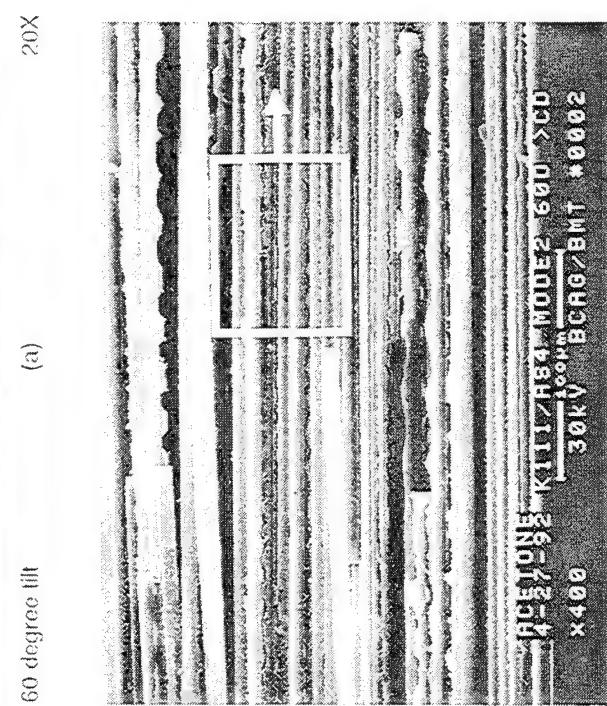
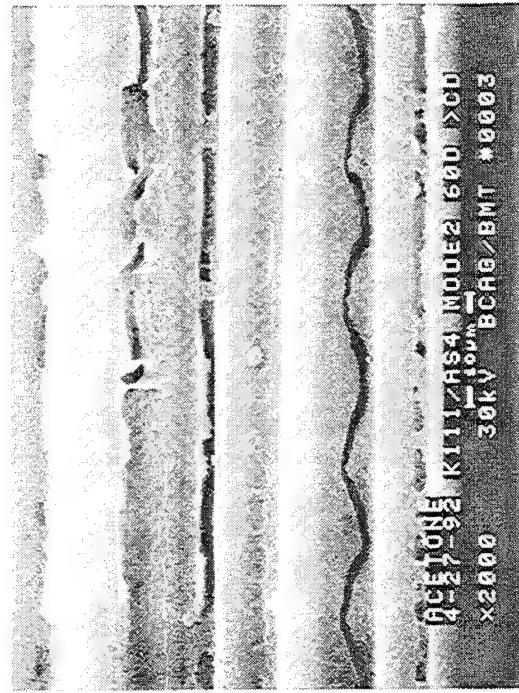
Figure 3.2-23. SEM Fractographs of a KI/II/AS4 interlaminar Mode II shear fracture surface exposed to Acetone for 24 hours
2405.03.9-5576 D1ai

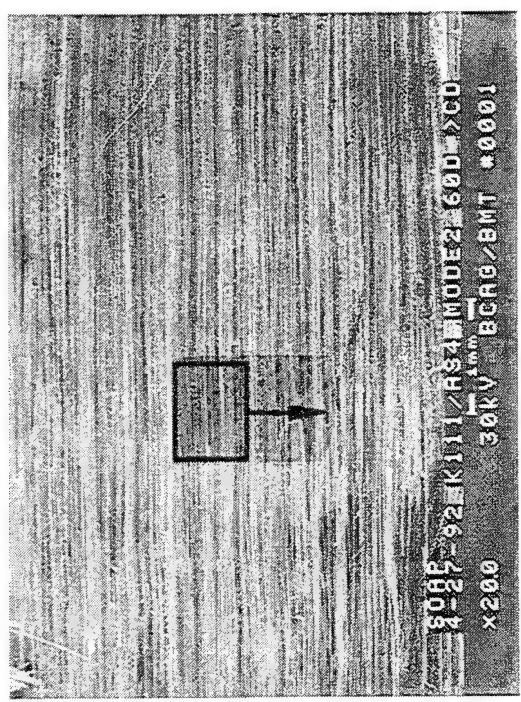
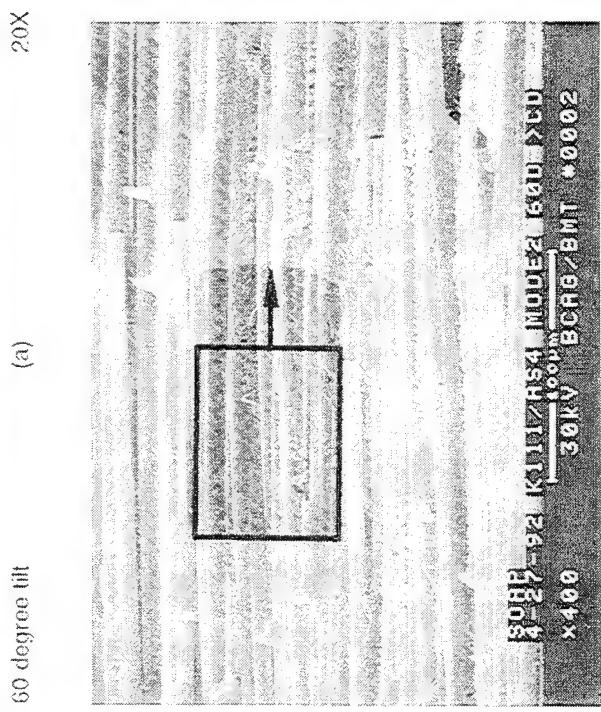
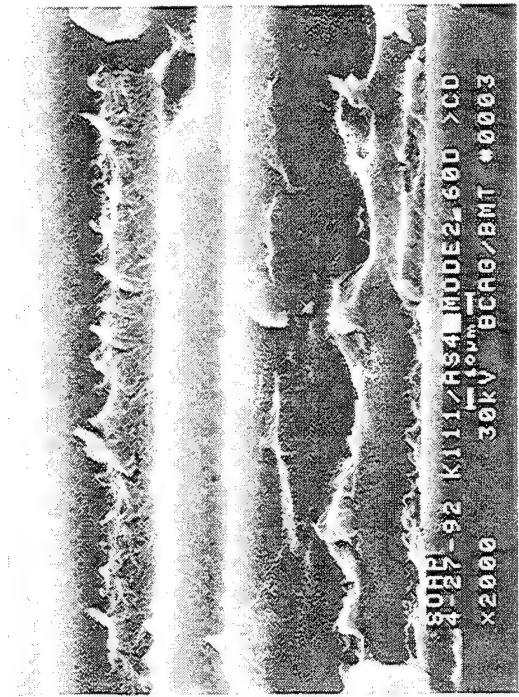
Figure 3.2-24. SEM Fractographs of a KI/II/AS4 interlaminar Mode II Shear Fracture Surface Exposed to Soap Solution for 24 Hours

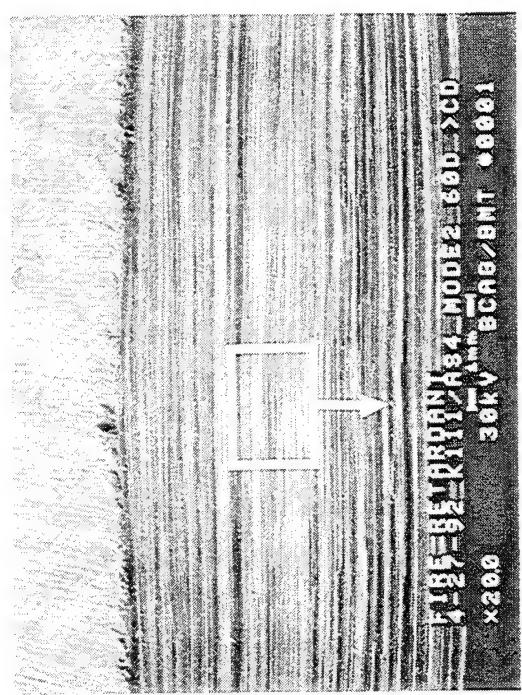
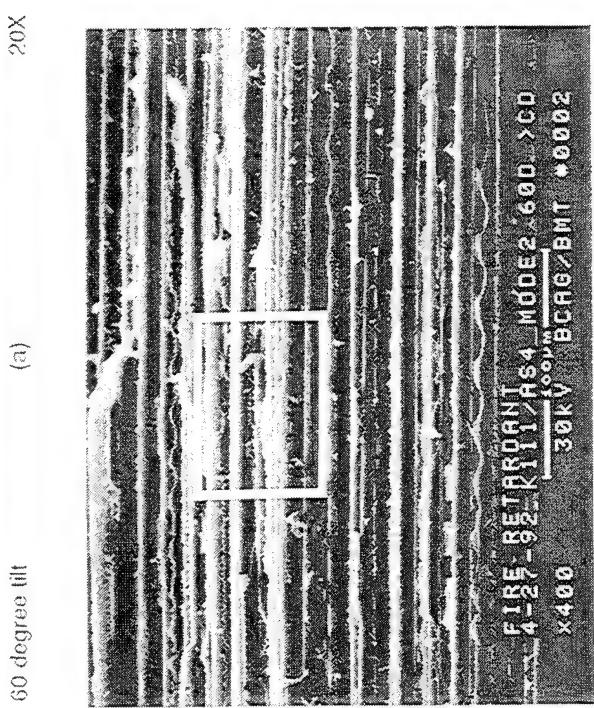
Figure 3.2-25. SEM fractographs of a K11/ASA interlaminar Mode II Shear Fracture Surface Exposed to Fire Retardant Foam for 7 Days

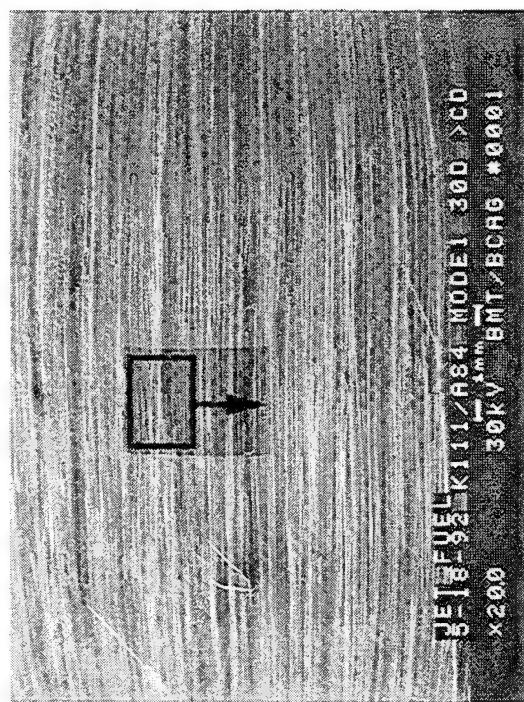
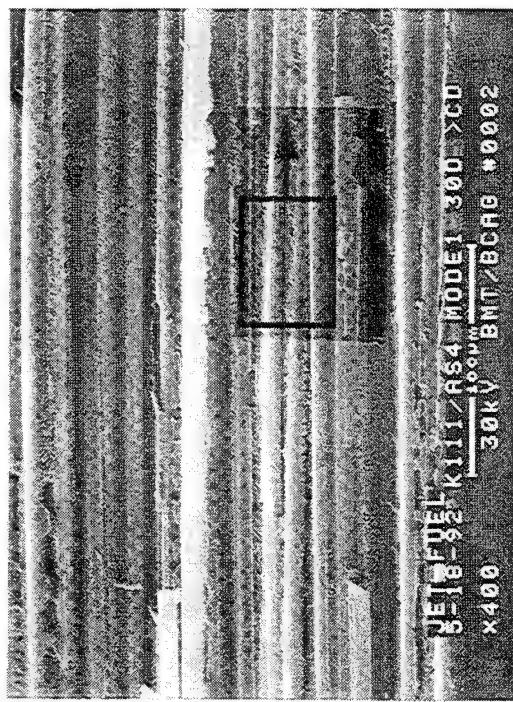
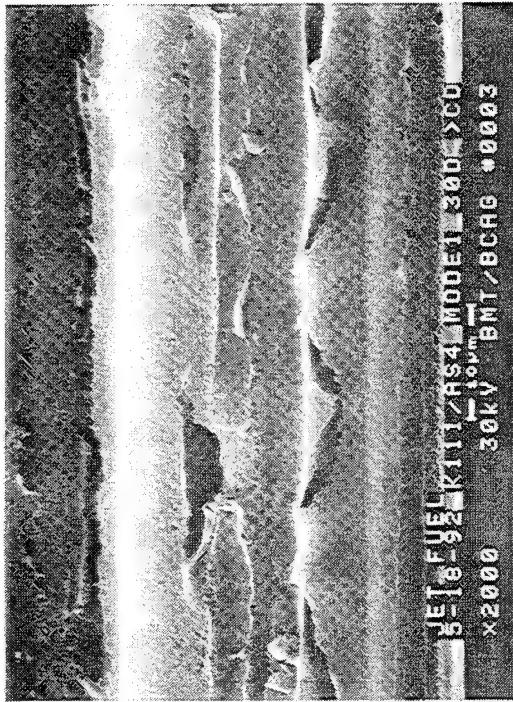
Figure 3.2-27. SEM fractographs of a KIII/AS4 interlaminar Mode I Tension Fracture Surface Exposed to $J^{\prime\prime}4$ Jet Fuel for 7 Days

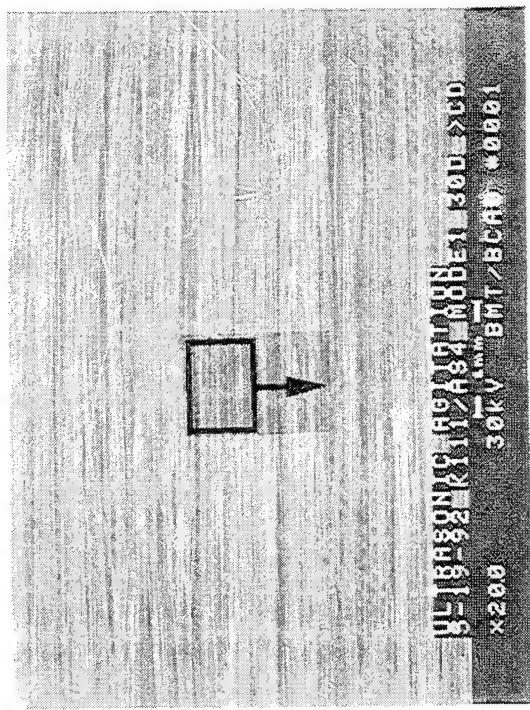
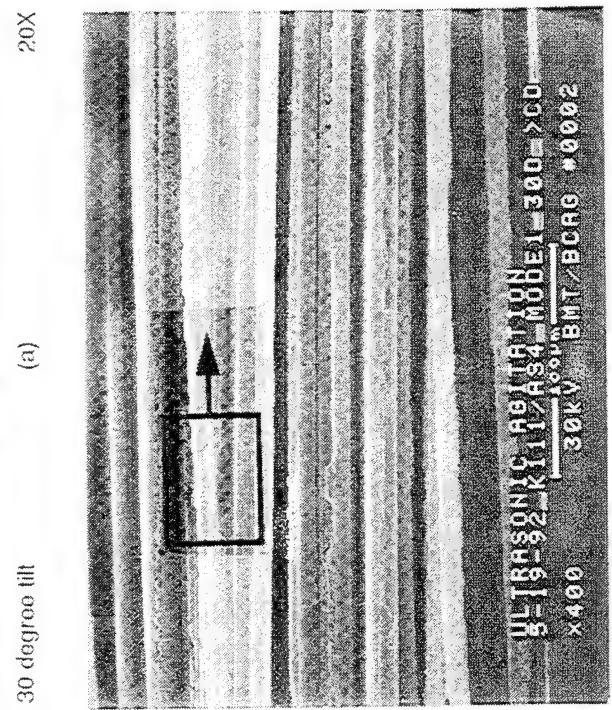
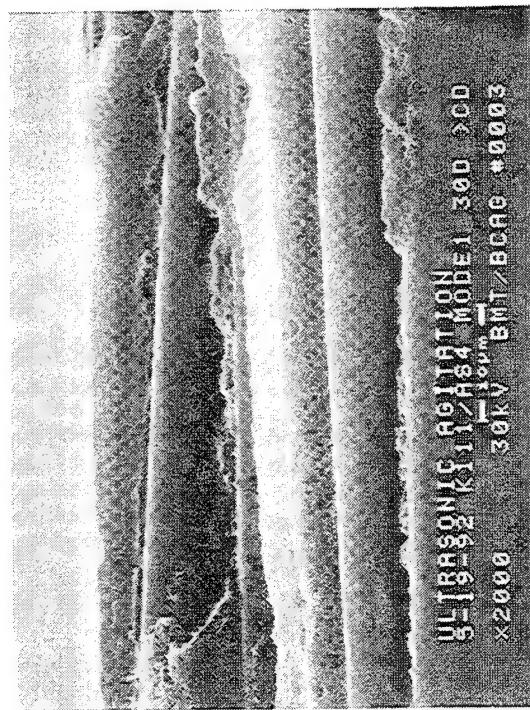
Figure 3.2-28. SEM Fractographs of a KII/AS4 Interlaminar Mode I Tension Fracture Surface Exposed to Ultrasonic Agitation in Distilled Water for 24 hours

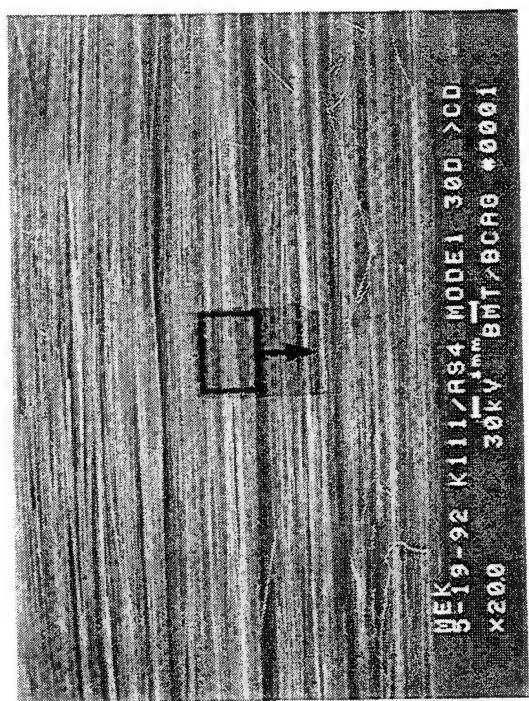
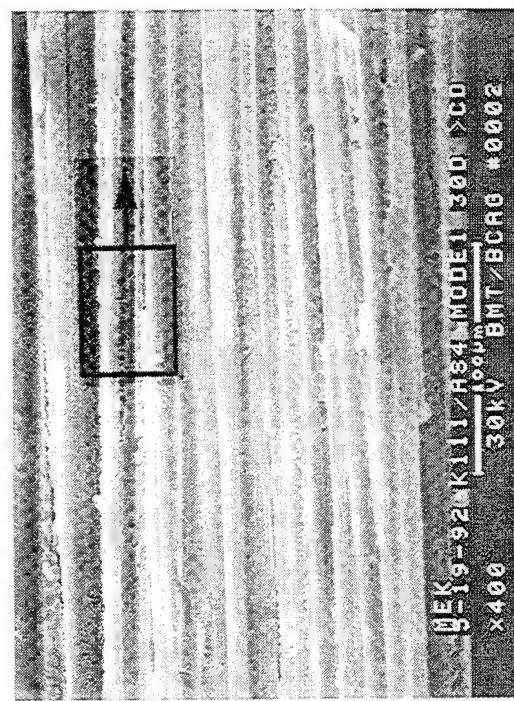
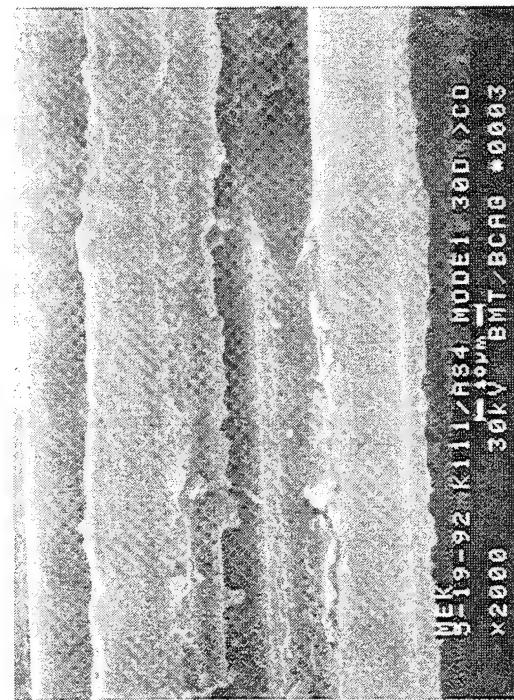
Figure 3.2-29. SEM Fractographs of a K11/AS4 Intertaninar Mode I Tension Fracture Surface Exposed to MEK for 24 hours

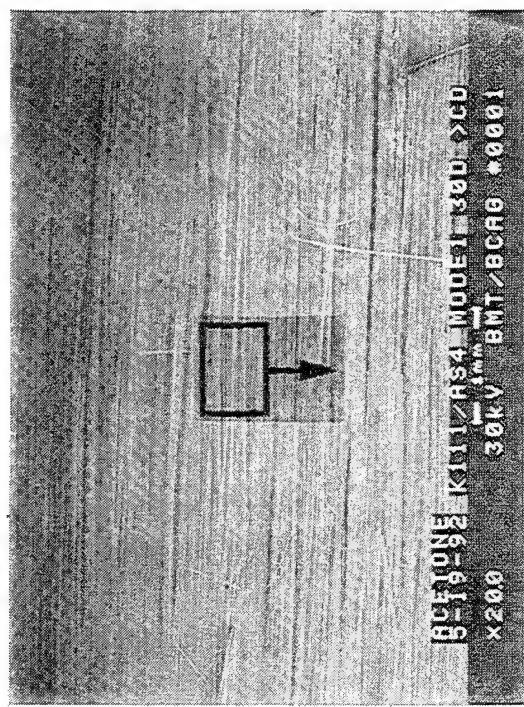
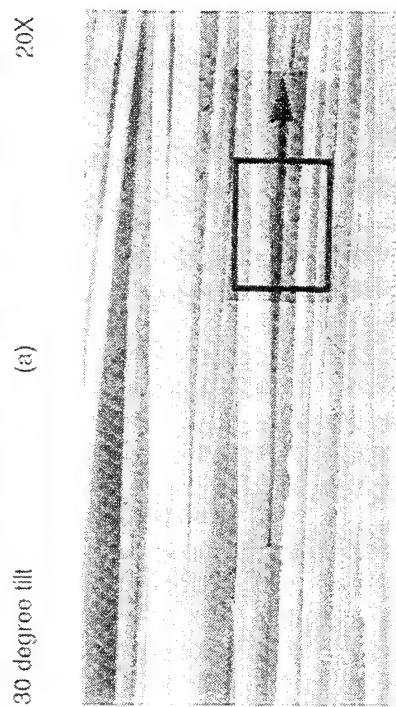
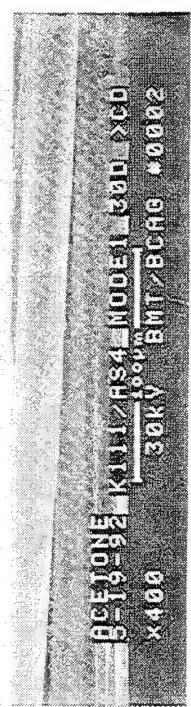
Figure 3.2-30. SEM fractographs of a KIb/AS4 interlaminar Mode I Tension Fracture Surface Exposed to Acetone for 24 hours

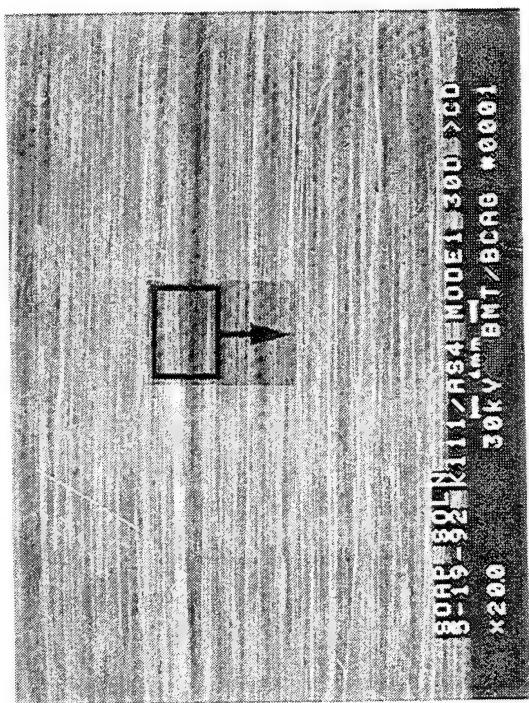
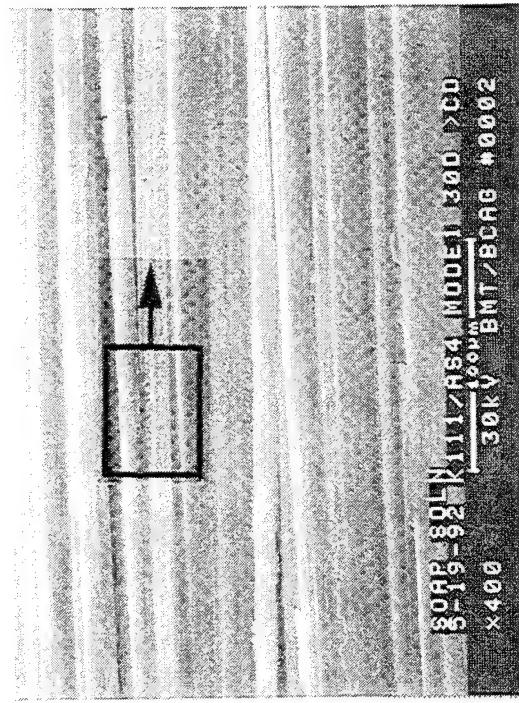
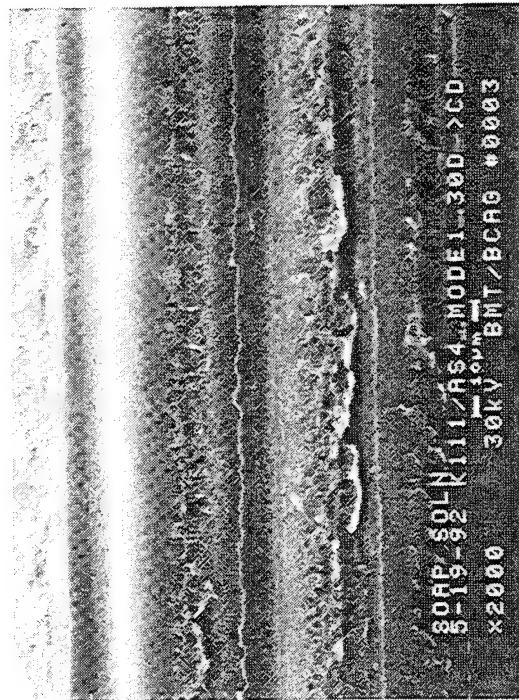
Figure 3.2-31. SEM Fractographs of a KH1000 Interlaminar Mode I Tension Fracture Surface Exposed to Soap Solution for 24 hours

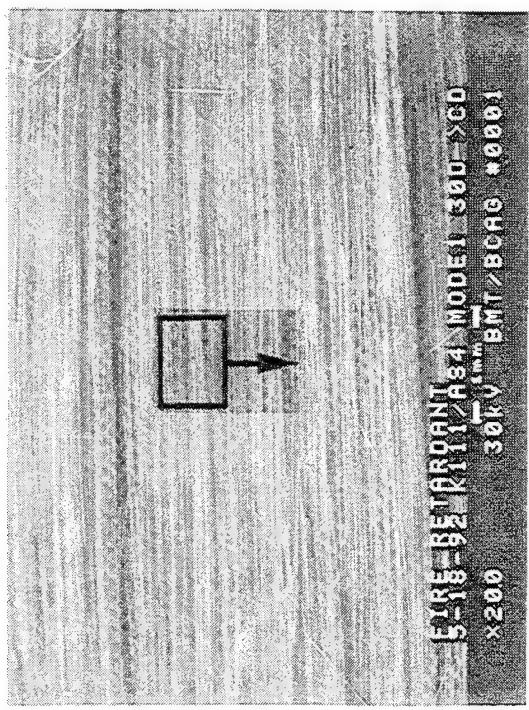
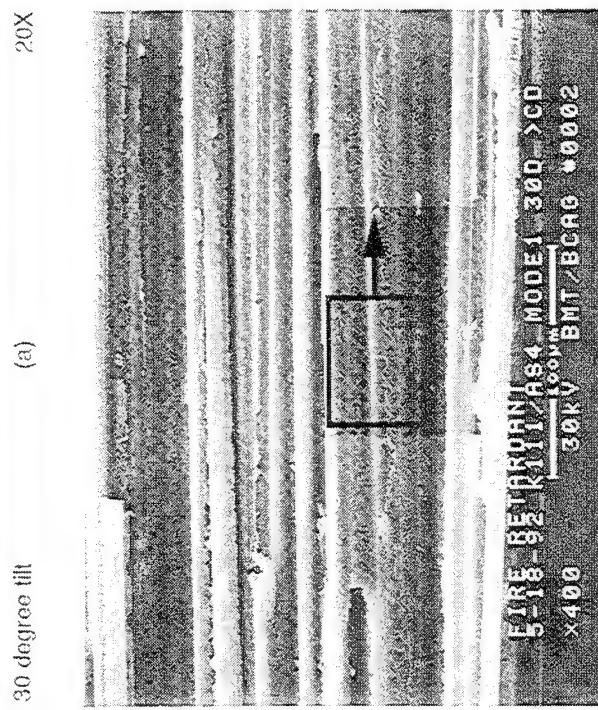
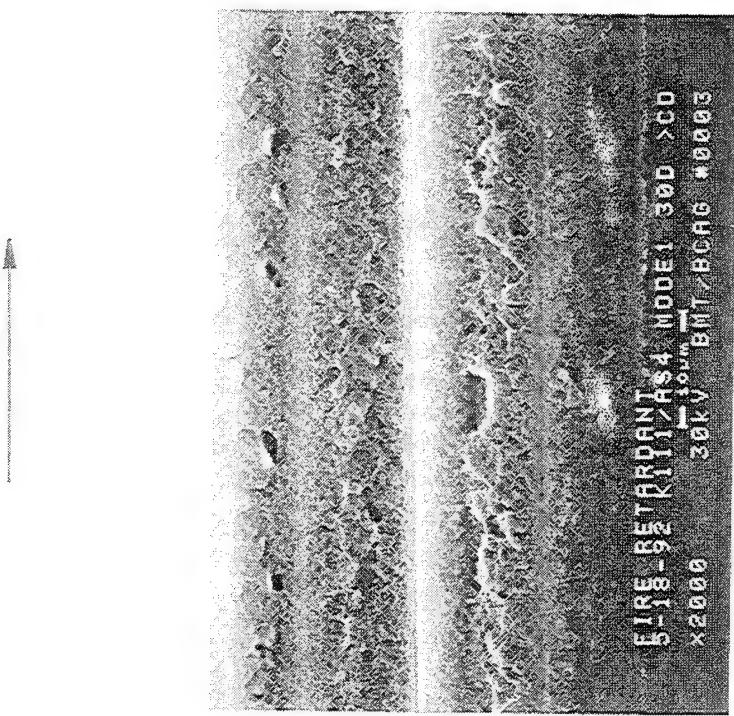
Figure 3.2-32. SEM fractographs of a KII/AS4 Intertaminar Mode I Tension Fracture Surface Exposed to Fire Retardant Foam for 7 Days

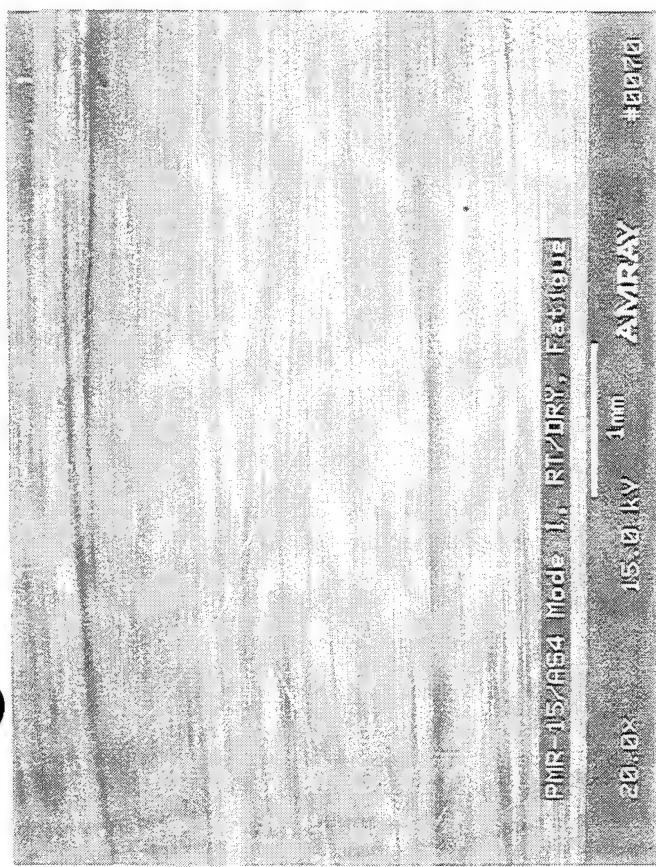
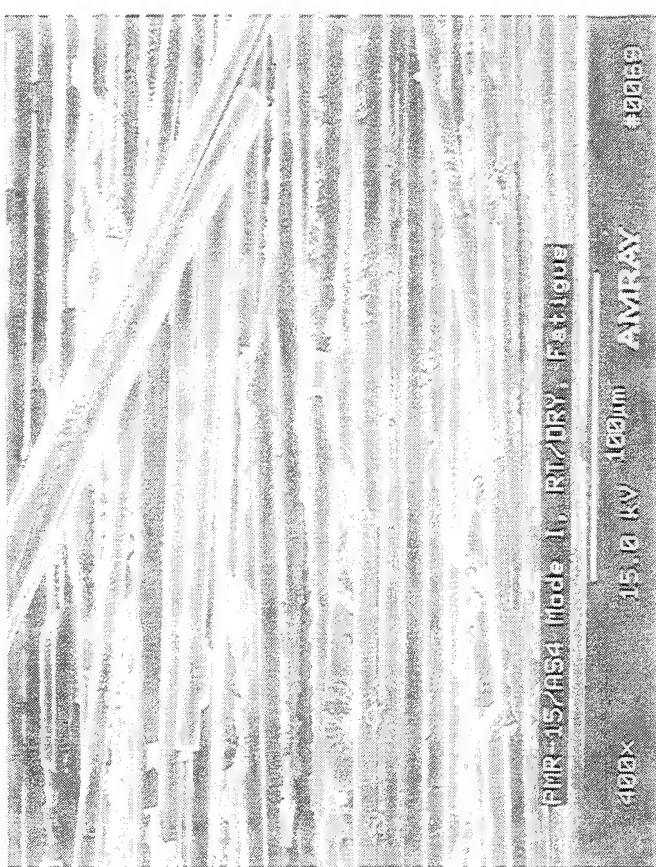
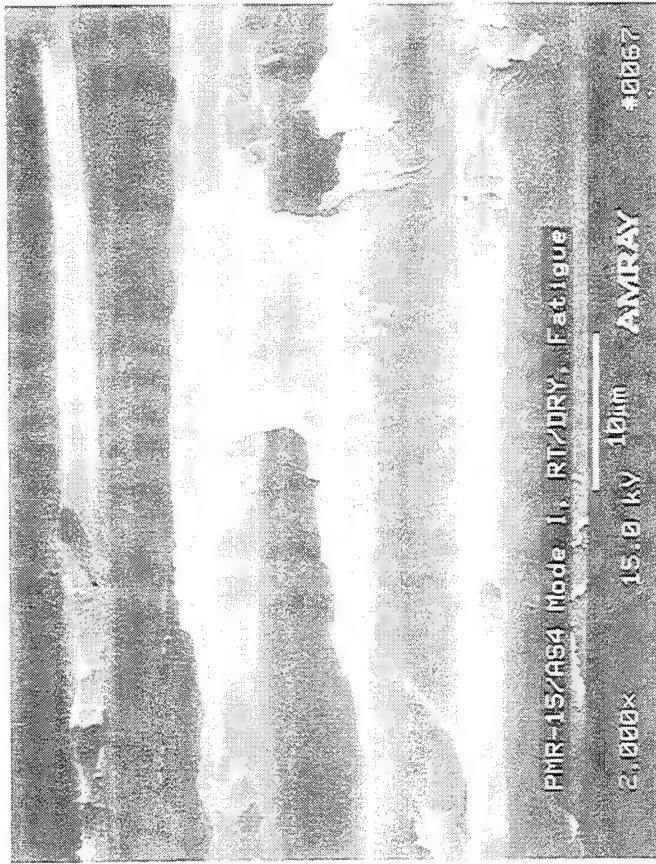
The overall surface morphology exhibited similar features as the fracture surface of a statically loaded specimen (Figure 3.3-1). Rivermarks and hackles were observed including fatigue striations. However, the striation features, which were usually located in fiber pull out troughs, were very difficult to identify even at very high magnifications (Figure 3.3-2a). These striations were also observed in resin rich regions, which resembled typical "beach marks" in fatigued metals (Figure 3.3-2b).

Figure 3.3-1. SEM Fractographs of a PMR-15/ASA4 Intercalaminar Mode I tension Fatigue Fracture Surface, RT/DRY

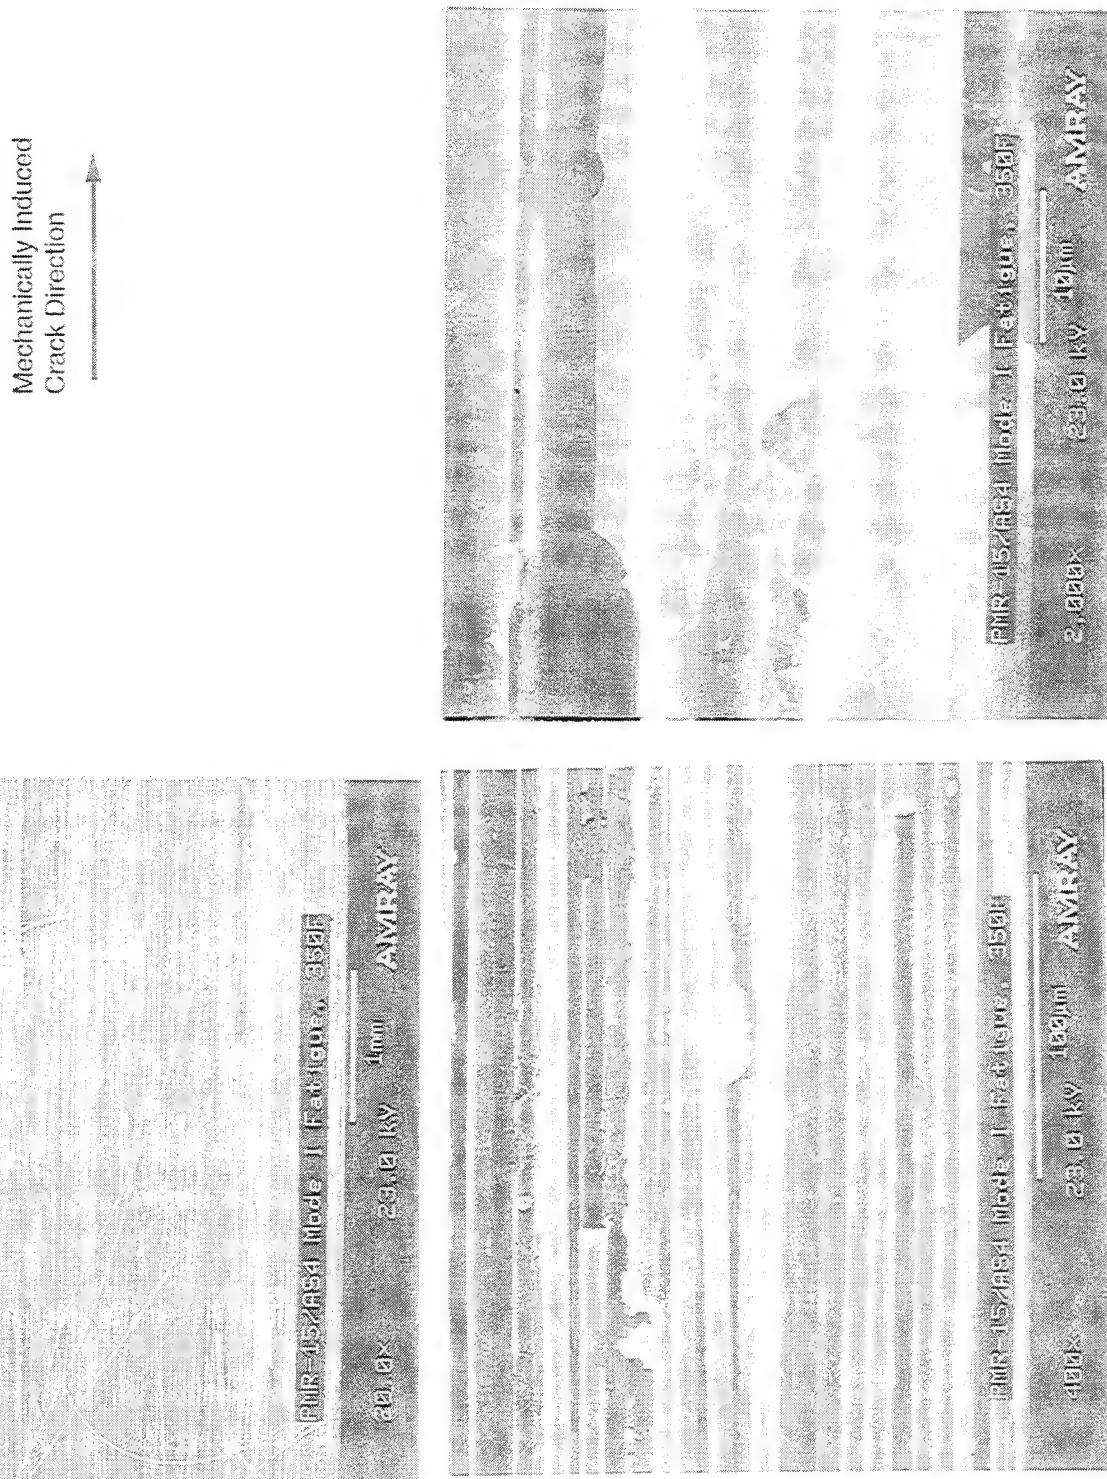
However the 350°F specimen fracture surface did not exhibit the typical mode I (tension) features. The fracture features were not distinct enough to determine the overall crack propagation direction

Figure 3.3-4. SEM Fractographs of a PMR-15/AS4 Interlaminar Mode I (Tensile) Fatigue Fracture Surface, 350° F

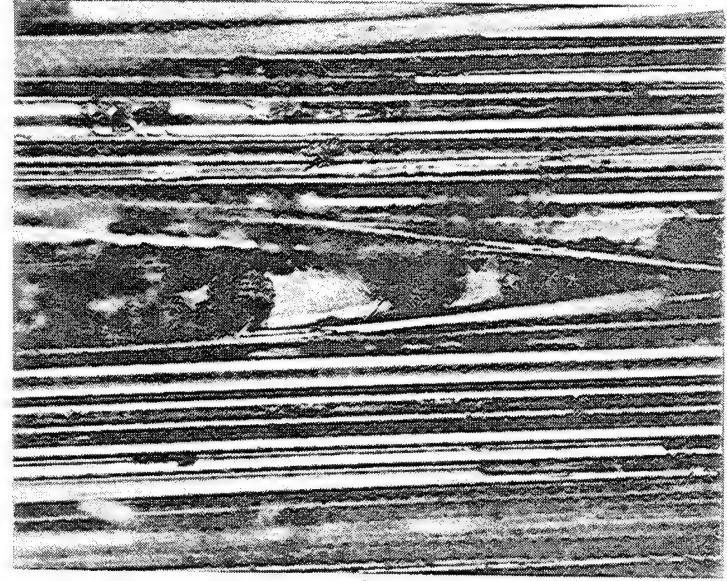
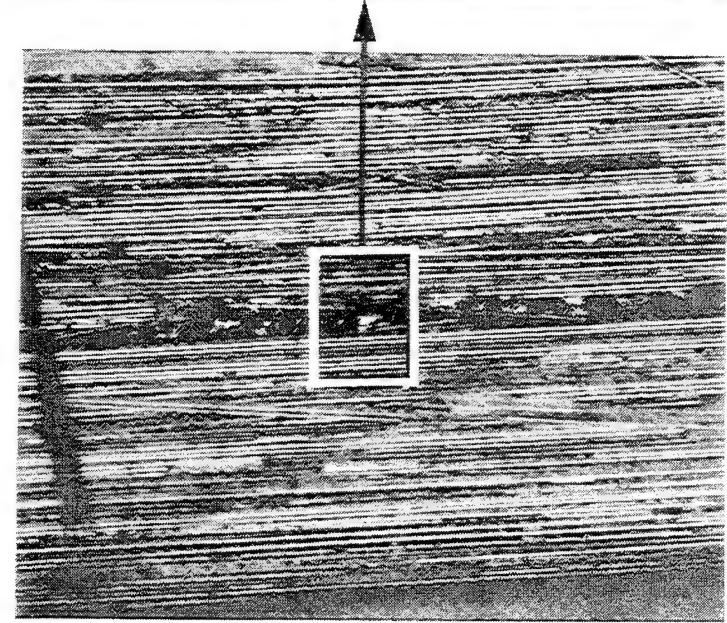
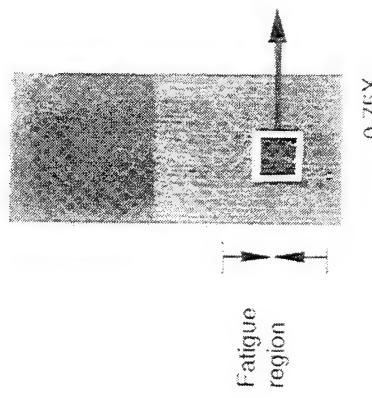
Figure 3.3-5. Optical fractographs of PMI-15/MS4 Intermittent Mode II (Shear) Fatigue, Room Temperature, High Stress

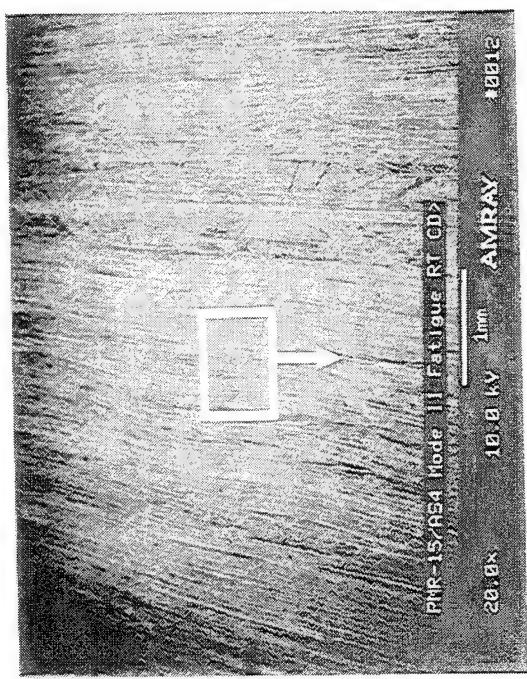
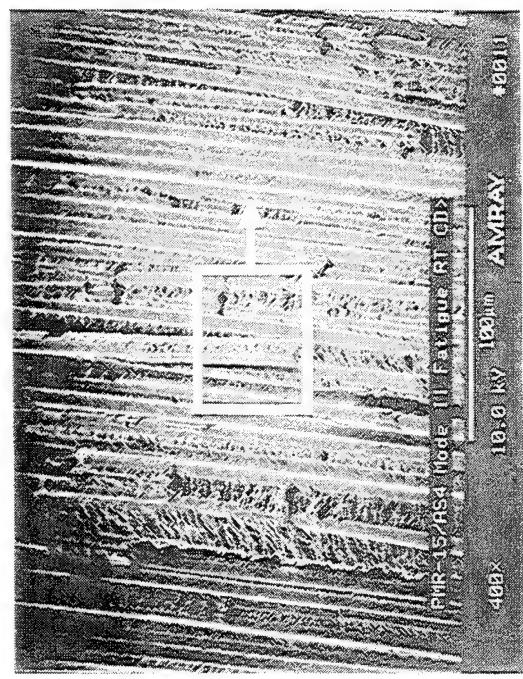
Figure 3.3-6. SEM Fractographs of a PMR-15/AS4 Intertaninar Mode II (Shear) Fatigue Fracture Surface, Room Temperature

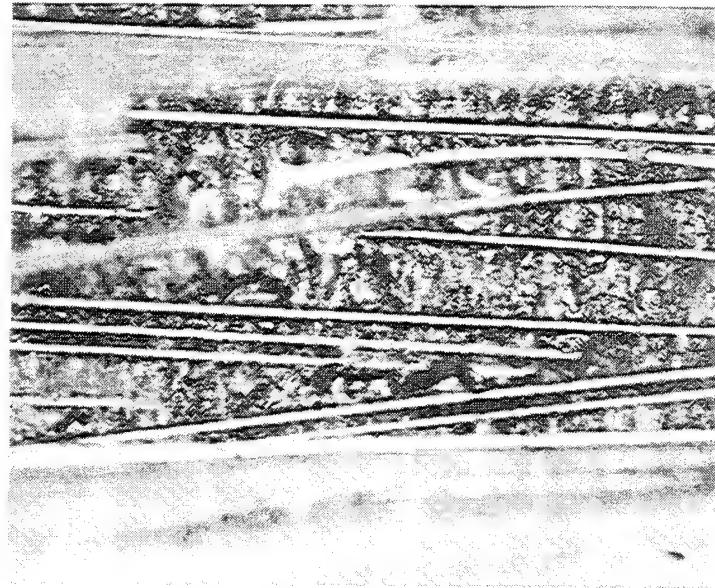
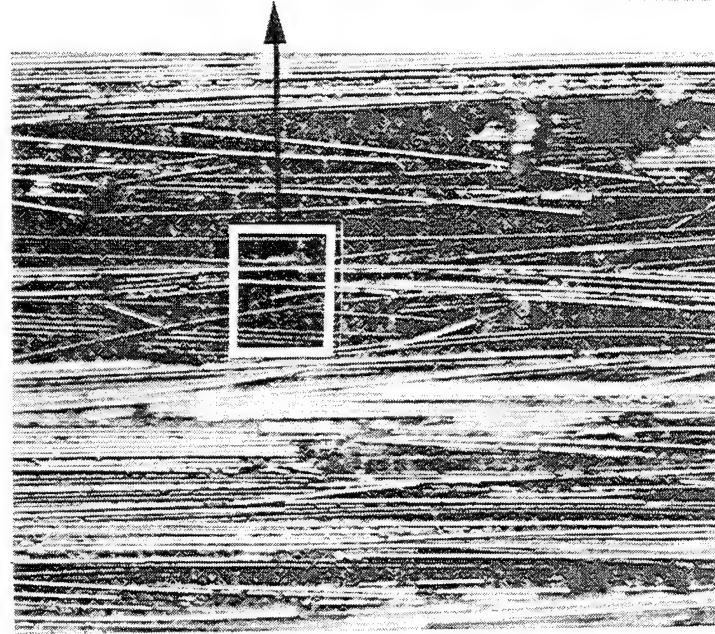
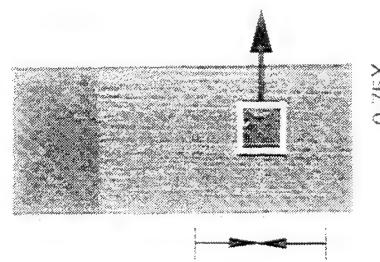
Figure 3.3-7. Optical trachographs of PMR-15/ASA4 Intertaninar Mode II (Shear) Fatigue, 35° σ f, High Stress

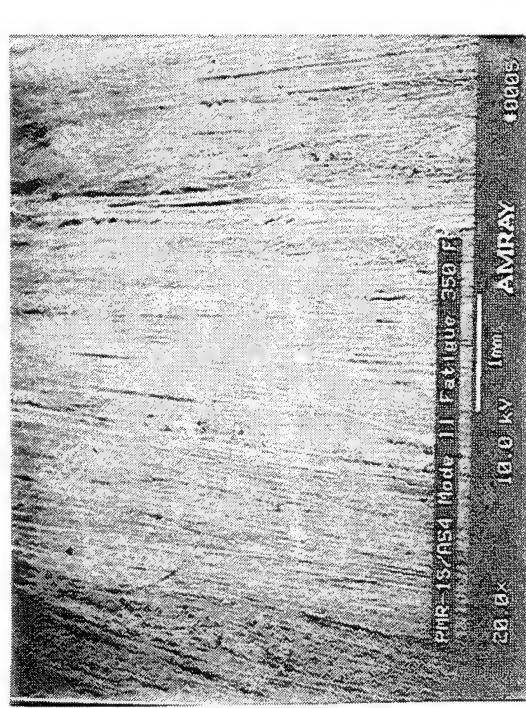
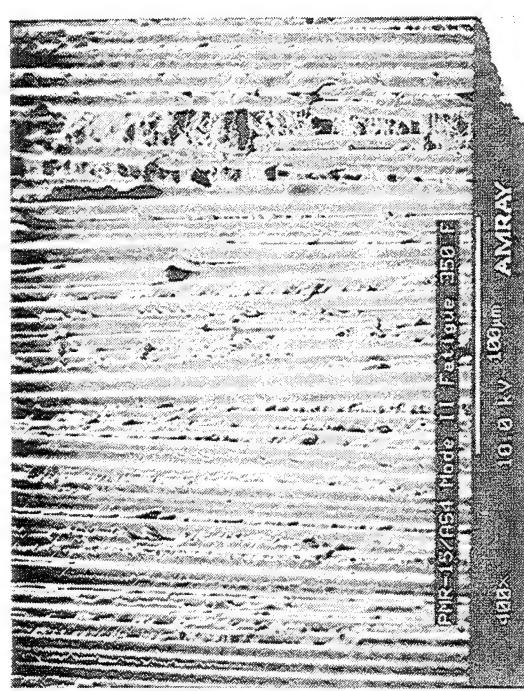
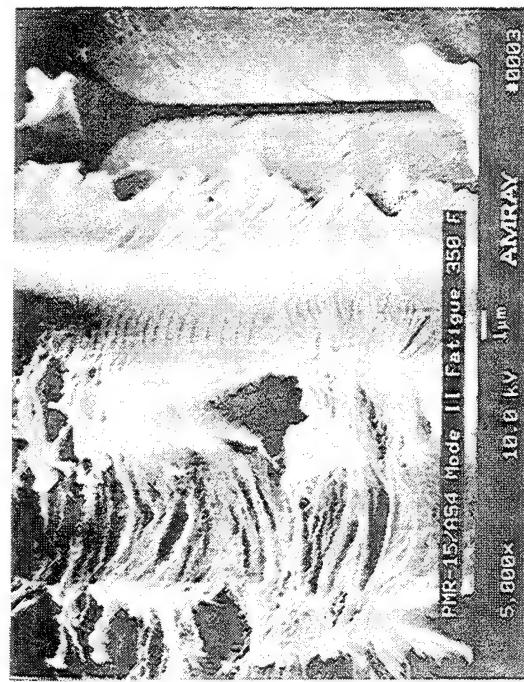
Figure 3.3-8. SEM fractographs of a PNR-15/AS4 Interlaminar Mode II (Shear) Fatigue Fracture Surface, 350°F

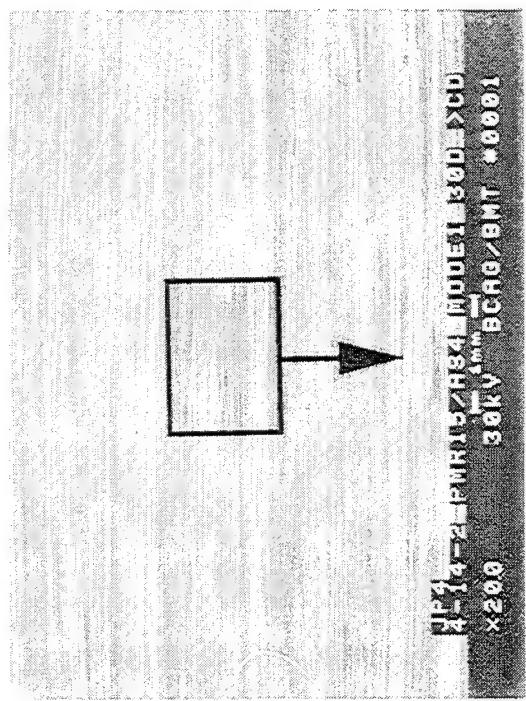
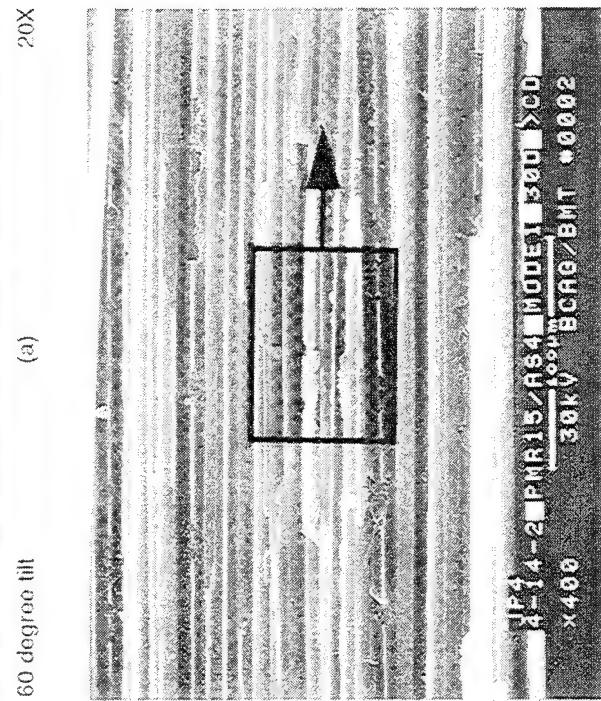
The effects of the exposure did not affect the fracture morphology to any noticeable degree. All of the characteristic mode I surface features were easily identified (Figure 3.3-9 through 3.3-15).

Figure 3.3-9. SEM Fractographs of a PMR-15/AS4 Interlaminar Mode I Tension Fracture Surface Exposed to JP4 Jet Fuel for 7 Days

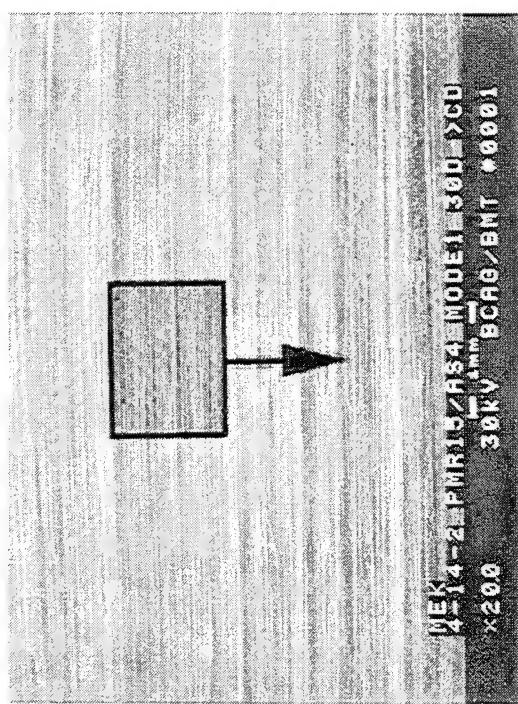
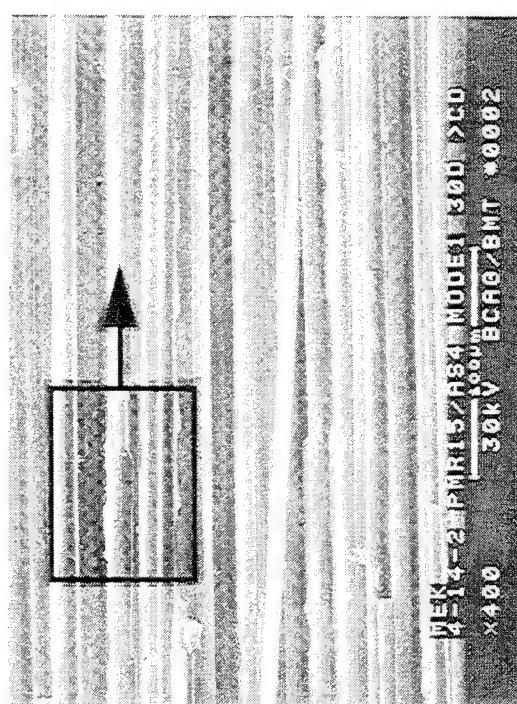
Figure 3.3-11. SEM Fractographs of a PMR-15/AS4 Interlaminar Mode I Tension Fracture Surface Exposed to MEK for 24 hours

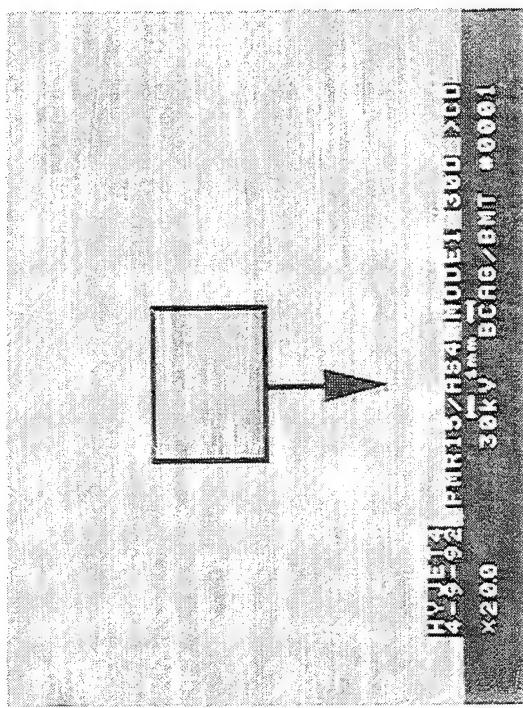
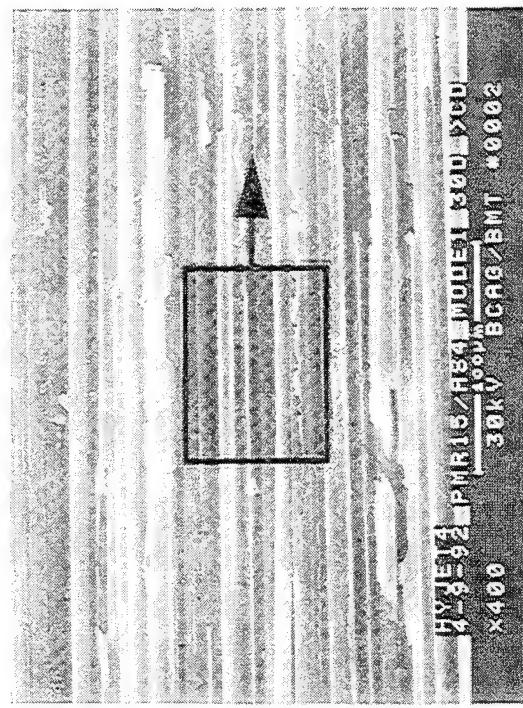
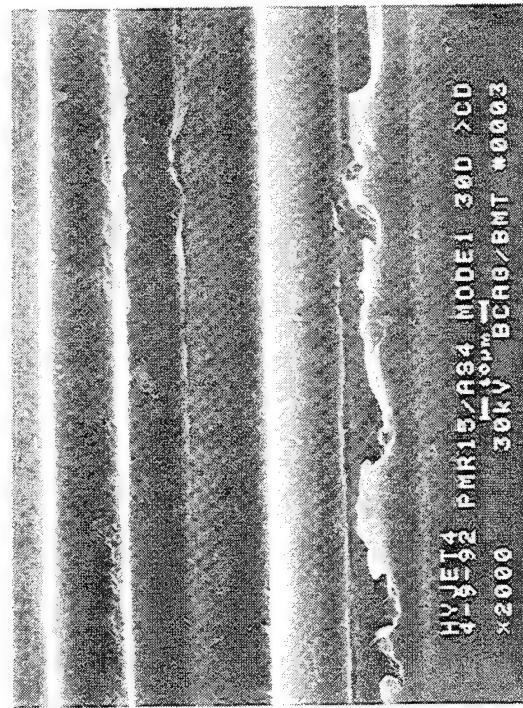
Figure 3.3-12 SEM fractographs of a PMMA-15ASA4 interlamellar model tension fracture surface exposed to hydraulic fluid for 7 days

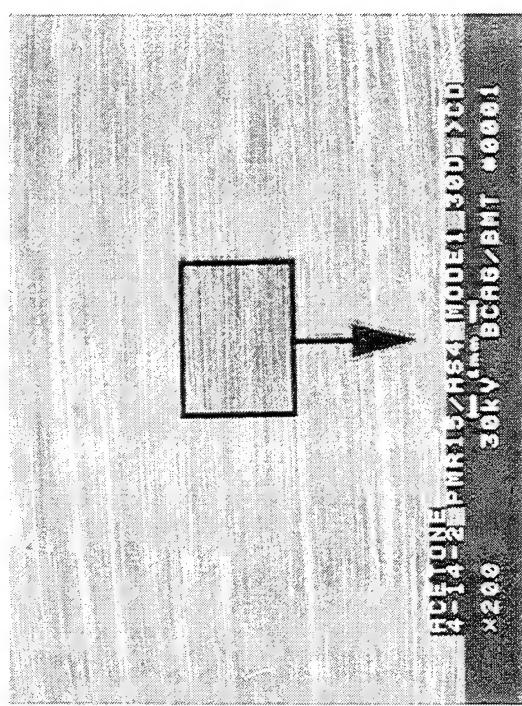
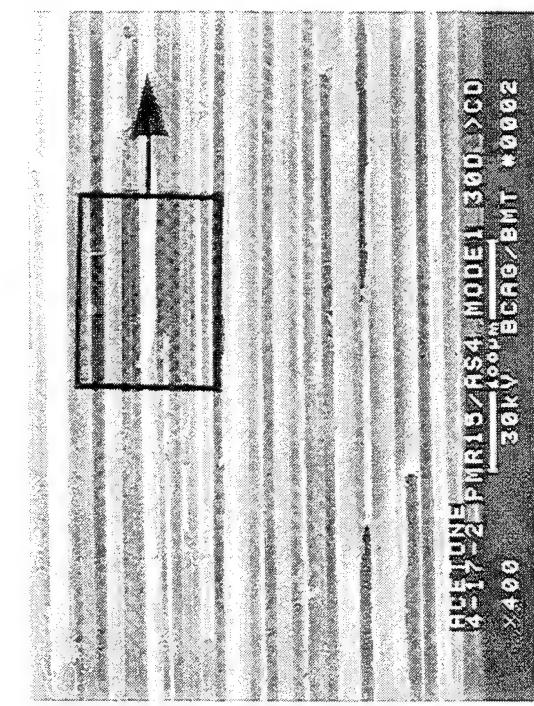
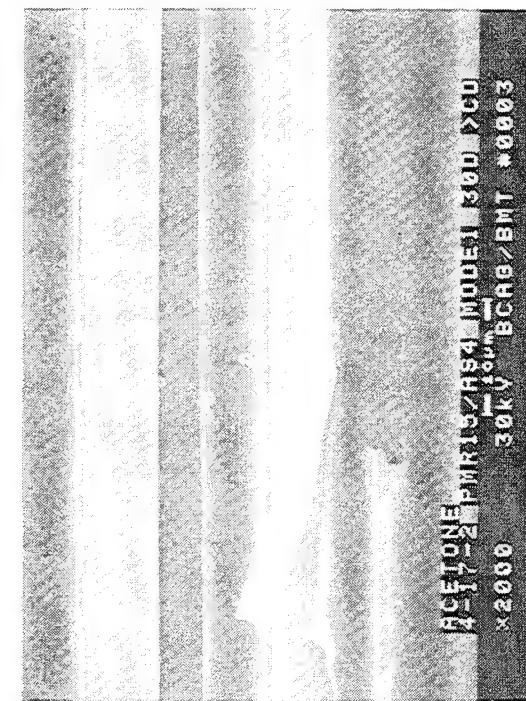
Figure 3-3-13. SEM Fractographs of a PMR-15/AS4 Interlaminar Mode I Tension Fracture Surface Exposed to Acetone for 24 hours
